Best Practice to Evaluate, Rehab, and Replace Local Road Bridges

Presenter: Mostafa Tazarv, PhD, PE

Presentation Prepared for:
**The 34th Annual North Central
Regional Local Road Conference**

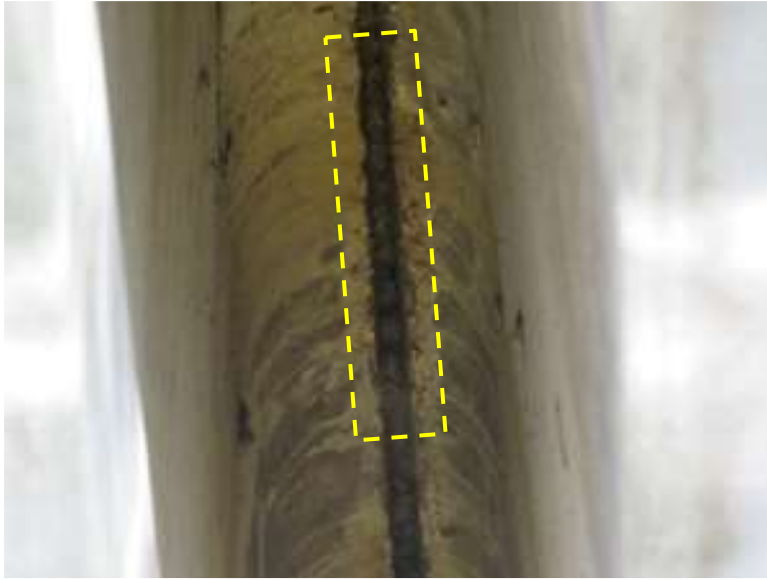
Stains from Minor
Corrosion of Steel Plates

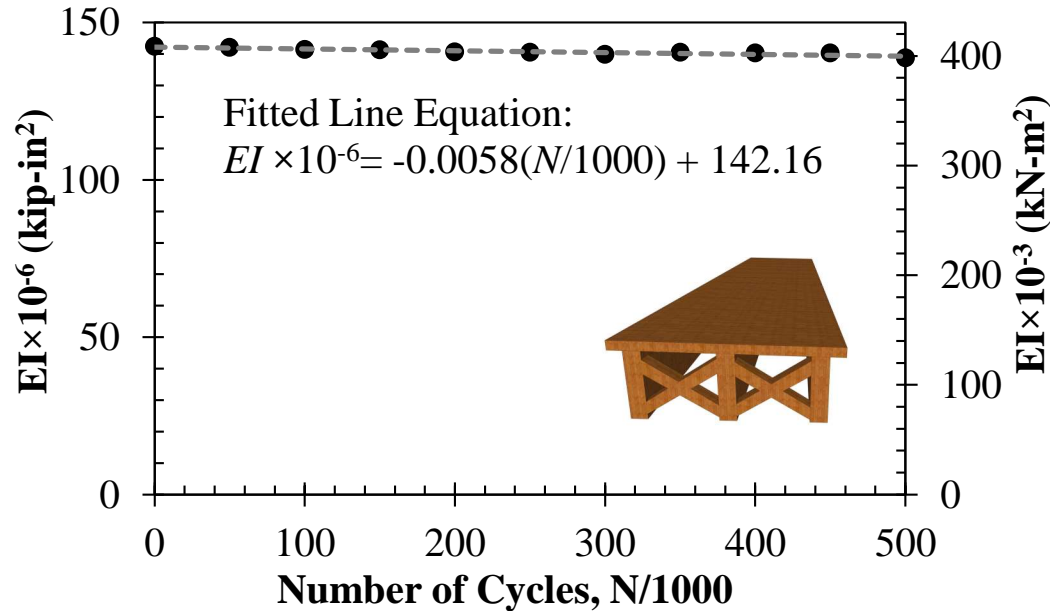
No stiffness degradation.
Damage of female-male panel-to-panel connections.
Use flat-end panels.

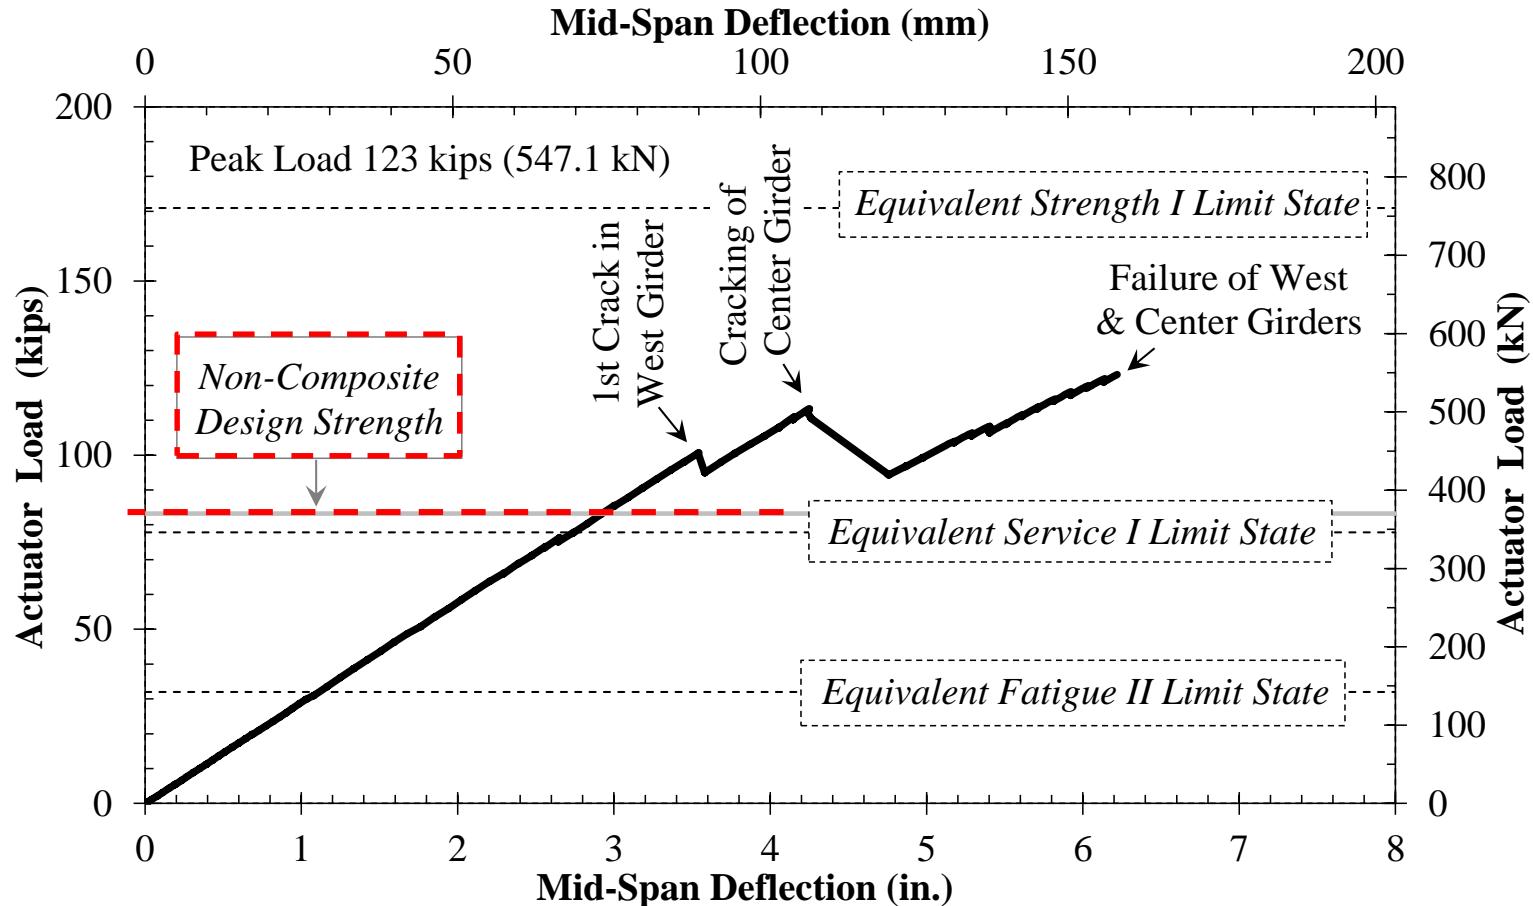
Bridge failed since a wrong grade of wood was used in construction. Timber girders should be designed fully non-composite.

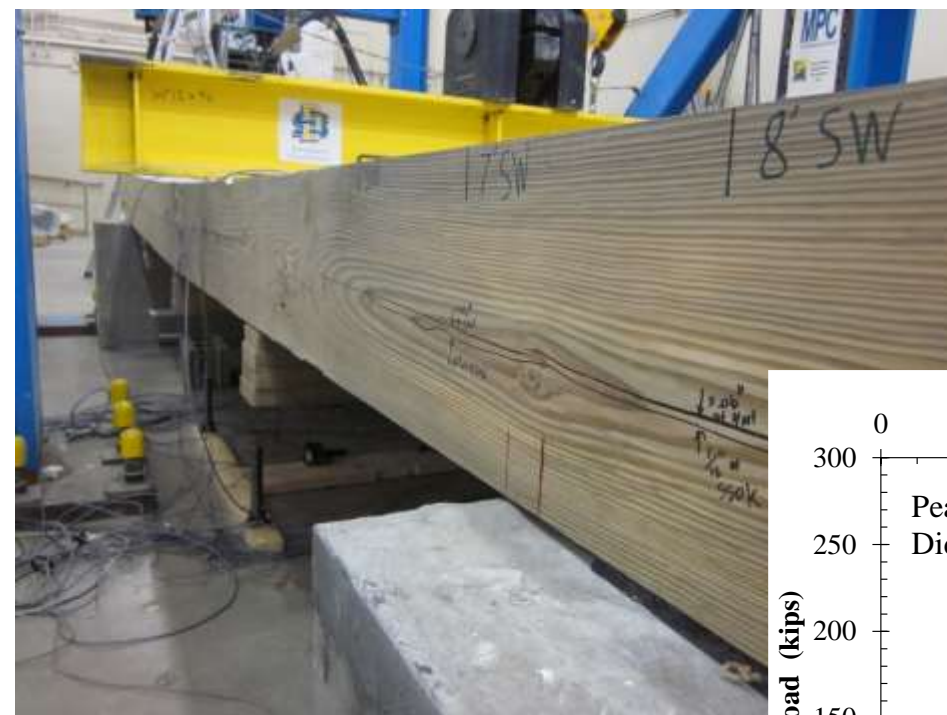
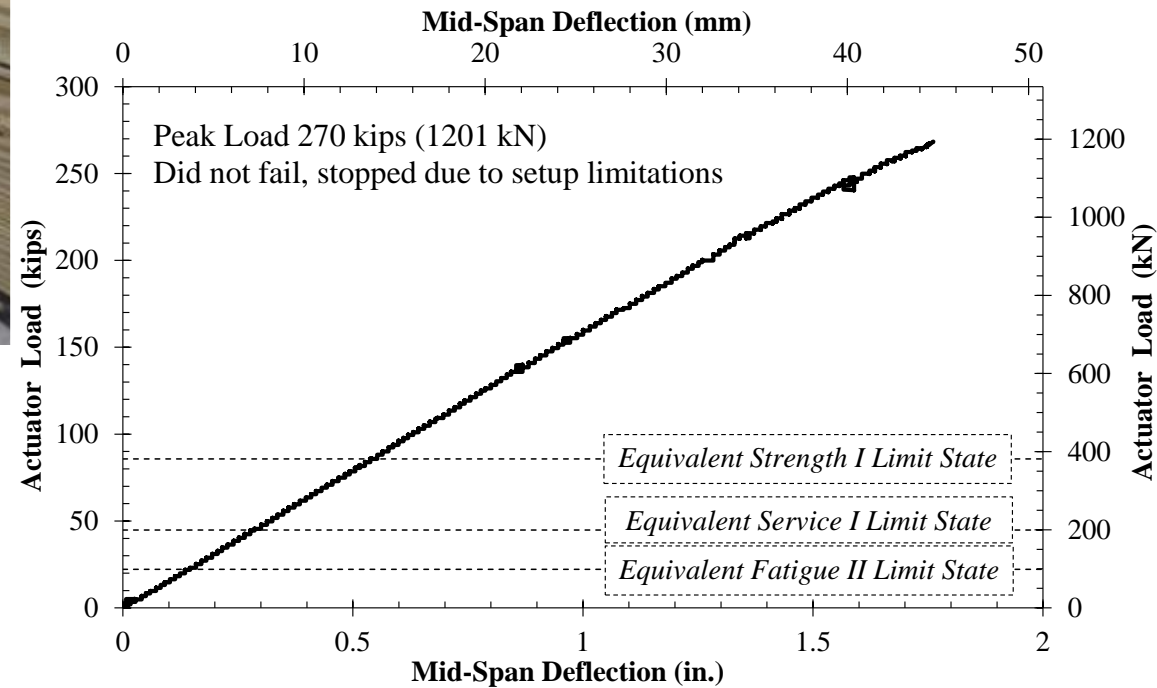
No damage at three times the AASHTO
Strength I Limit State load.

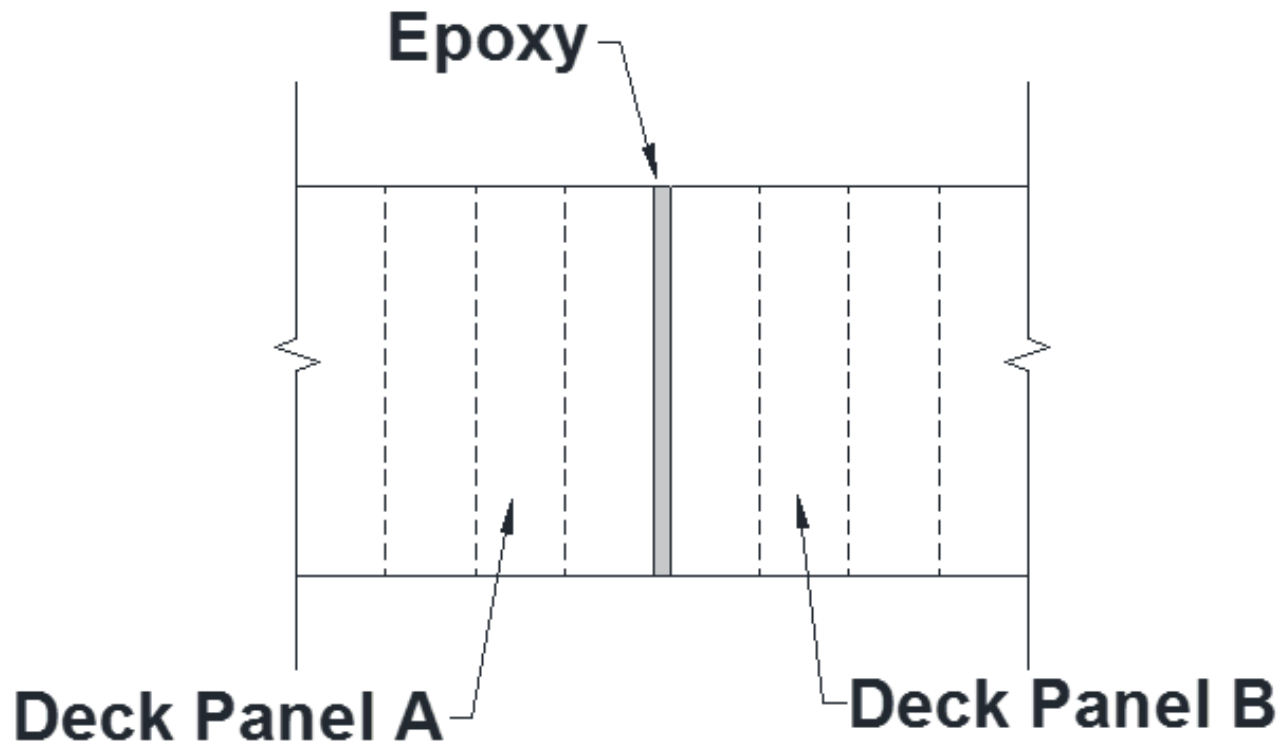
- The deck panels shall use a straight connection as shown.

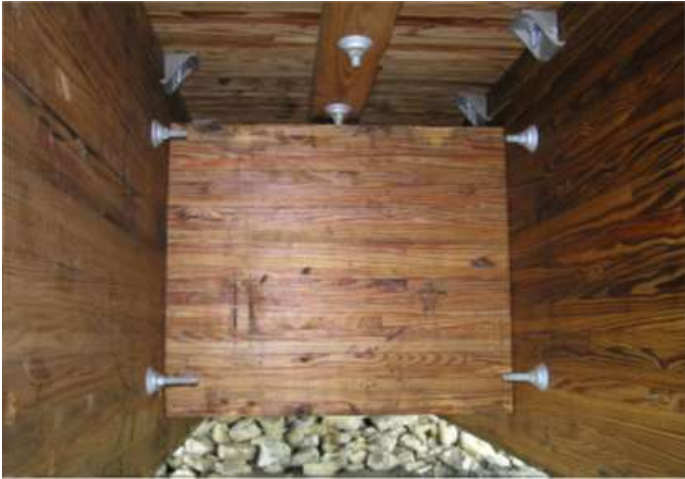
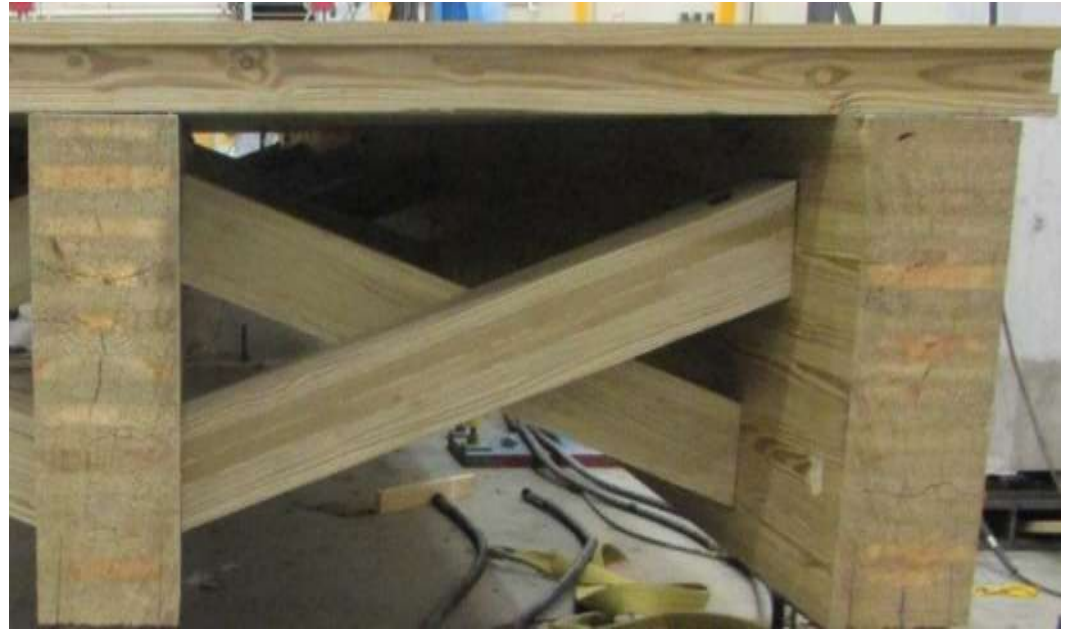
- Solid glulam diaphragms, steel cross braces, or glulam cross braces may be used.

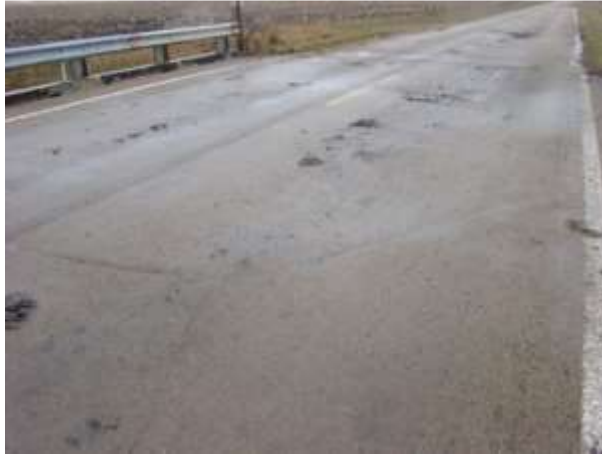
(a) Asphalt Overlay

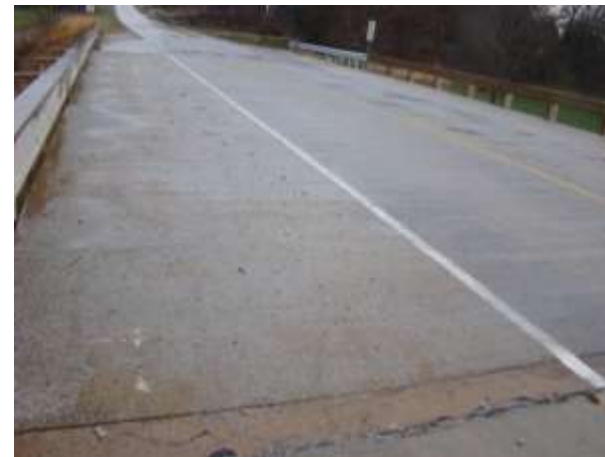
(d) Epoxy with Embedded Grit

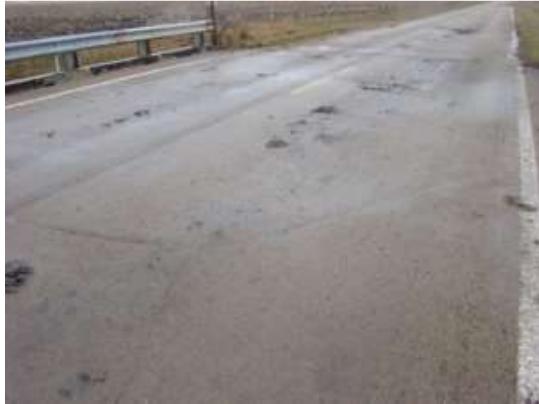
(a) Asphalt Overlay

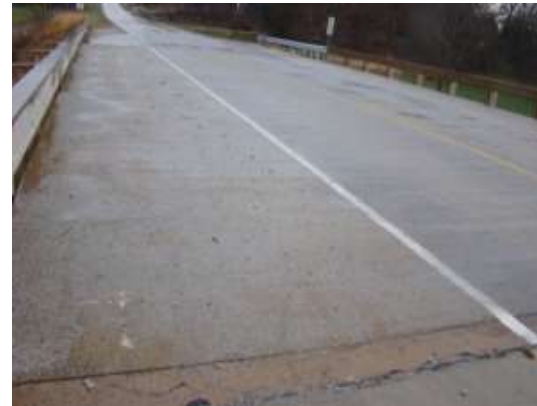
(d) Epoxy with Embedded Grit
