2020 INNOVATION CHAMPIONS CONTEST

Motor Grader Step

COUNTY: Golden Valley Highway Department

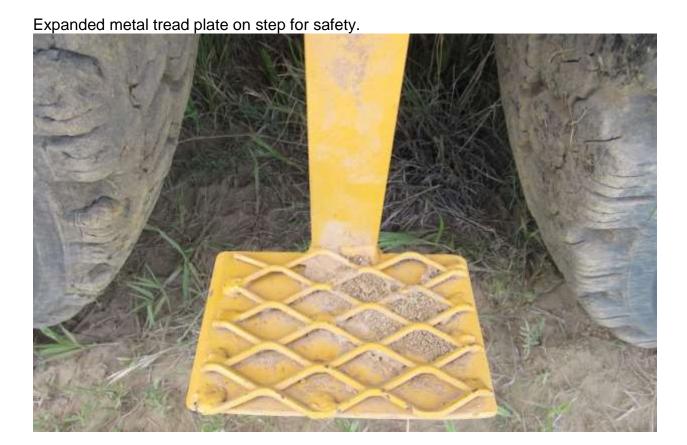
Side view with step up. Front bolt acts in part as hinge, rear bolt is a stop.
