Tire Safety

Reaching New Heights

34th Annual North Central Local Roads Conference
Rapid City, SD - October 16-17, 2019

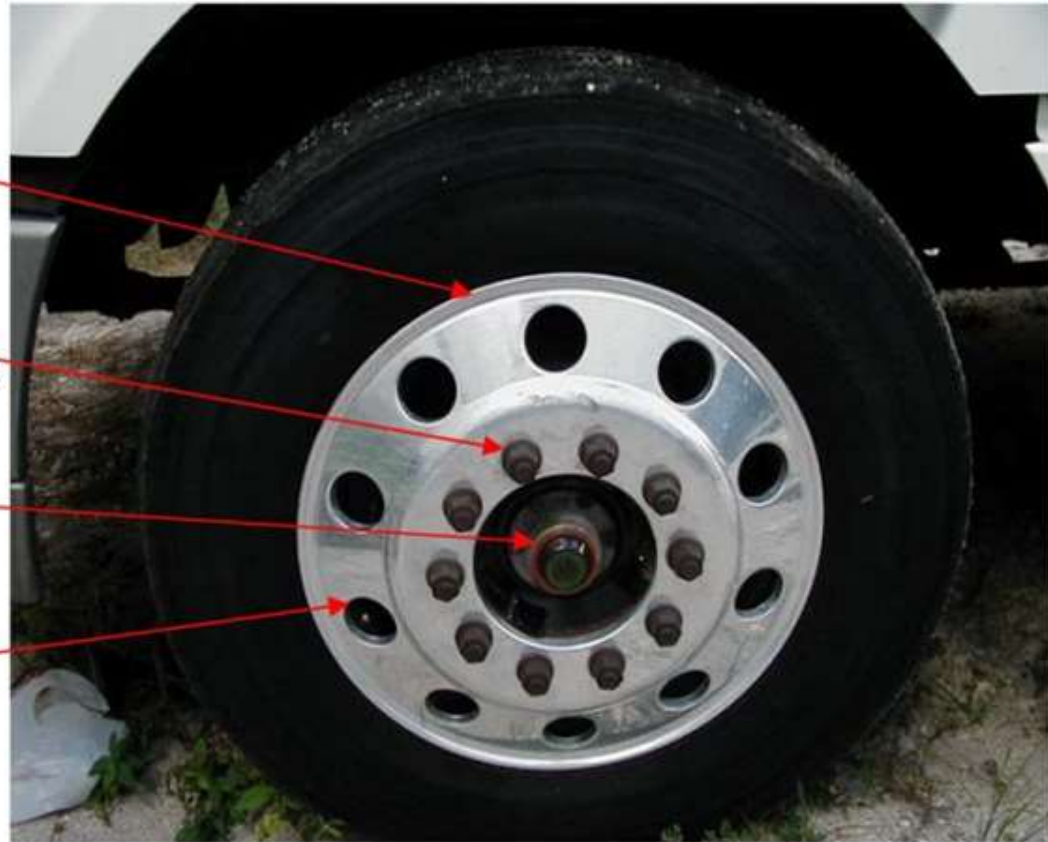
Lug Nuts:

- None are missing
- Tight – no shiny threads, or rust trails

Rim:

- Not bent
- Not cracked
- No welding repairs

Outer Hub Oil Seal:

- Not leaking
- No missing bolts
- Proper oil level

Valve stem:

- No cuts
- No damages
- No missing.

Space:

- Check for objects between wheels
- Check for proper spacing

Splash Guards:

- Not missing or torn and properly mounted

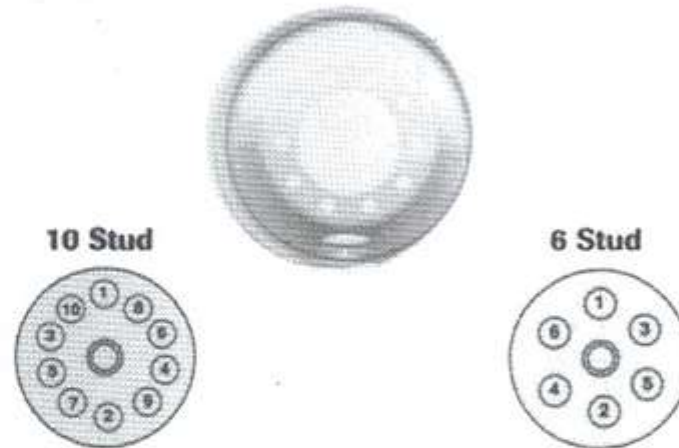
Stud Piloted Wheels

STUD PILOTED WHEELS

RECOMMENDED TORQUE - DRY:

- $\frac{3}{4}$ - 16 THREAD: 450 - 500 FT. LBS.
- $1 \frac{1}{8}$ - 16 THREAD: 450 - 500 FT. LBS.
- $\frac{15}{16}$ - 12 THREAD: 750 - 900 FT. LBS.
- $1 \frac{5}{16}$ - 12 THREAD: 750 - 900 FT. LBS.

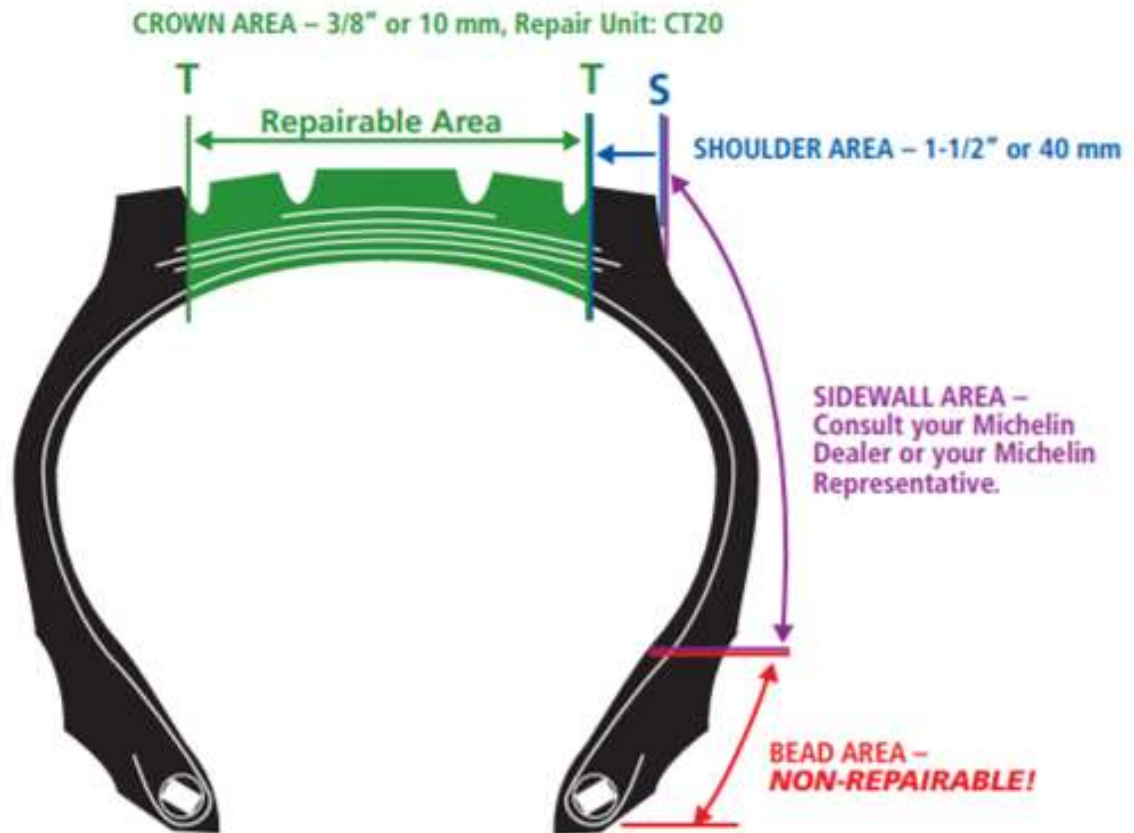
Nail Hole Limitations Chart

Maximum repairable nail hole diameter is 3/8 inch (T-T area).

All injuries larger than 3/8 inch or outside the specified T-T area, must be treated as a section repair.

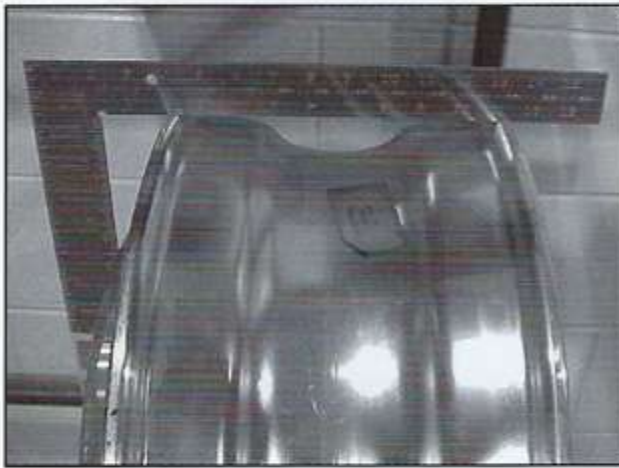
Acceptable

Heat Treated Wheels

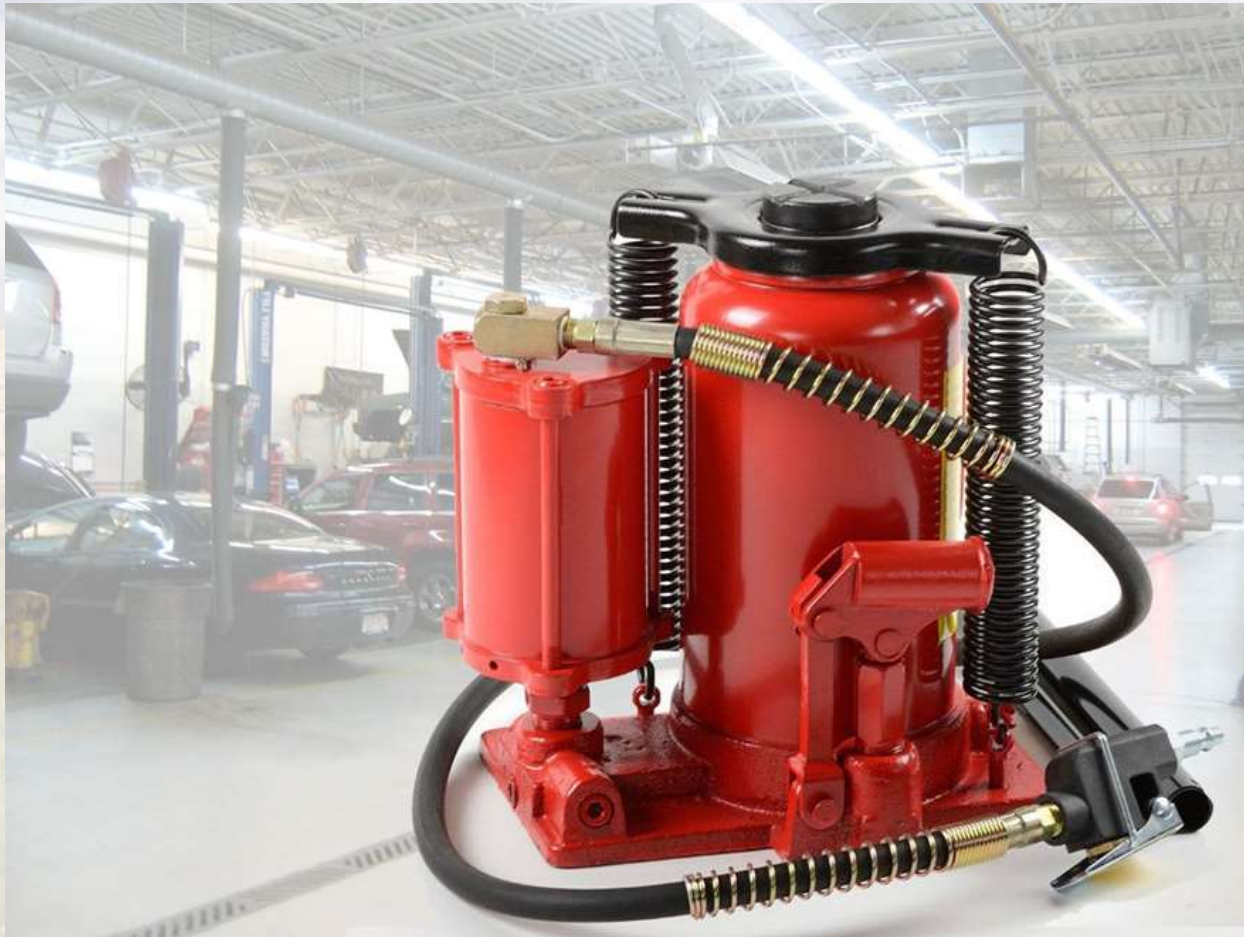
Hydraulic Air Jacks

Remember, when hydraulic jacks are used as support devices, all of the weight is actually supported by the seal at the bottom of the ram.

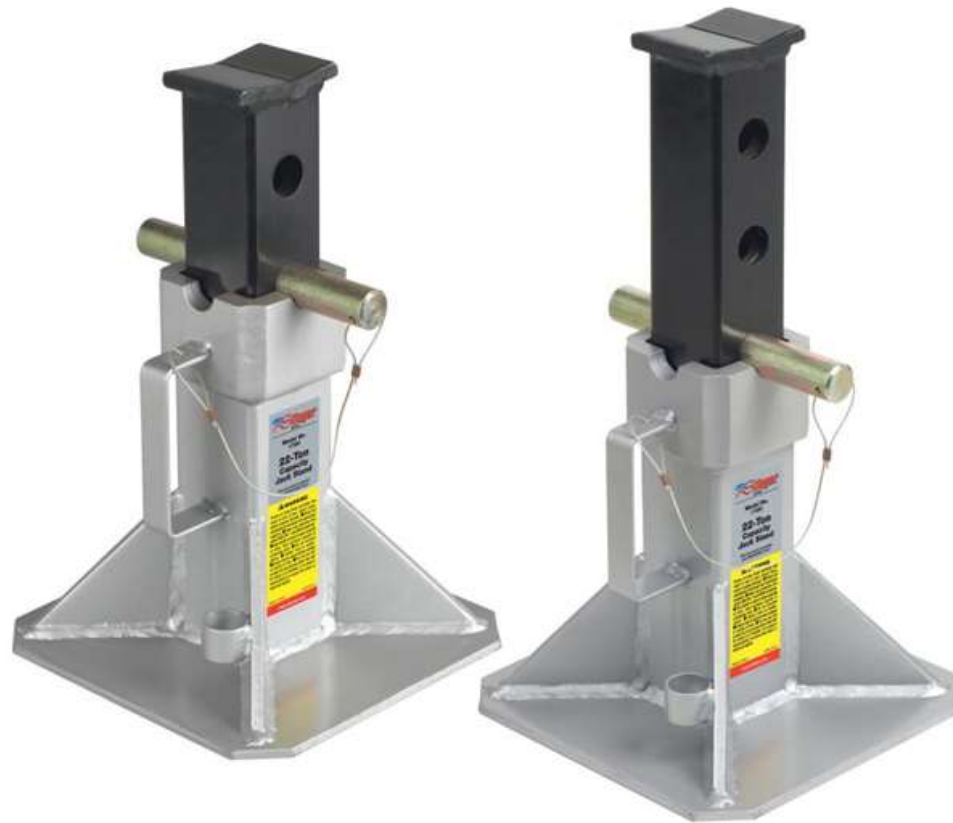
Jack Stands

Jack cannot contact the drain plug

It's also important to note that when using the differential, or pumpkin, to raise a drive axle, the jack cannot contact the drain plug.

Additionally, when lifting a fully loaded vehicle by the differential or in the middle of the axle tube may result in damage. In these instances, the best practice is to lift and support the axle at both ends.

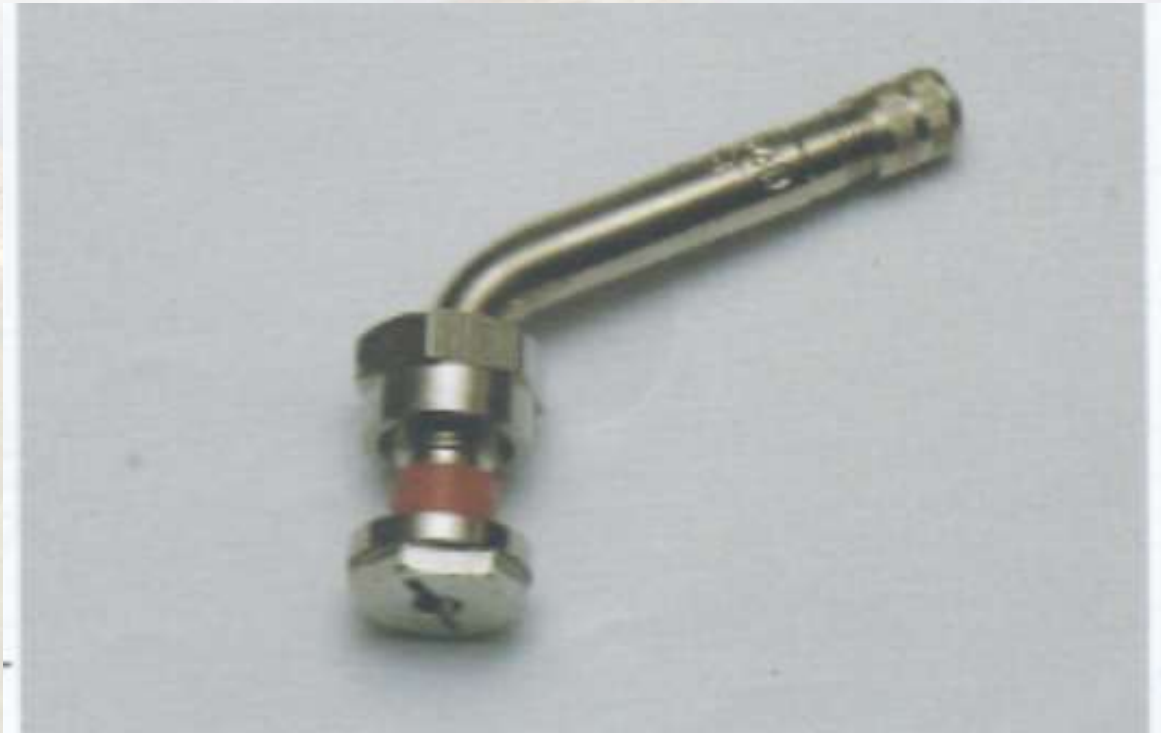
TR540, Torque 80-125 inch pounds

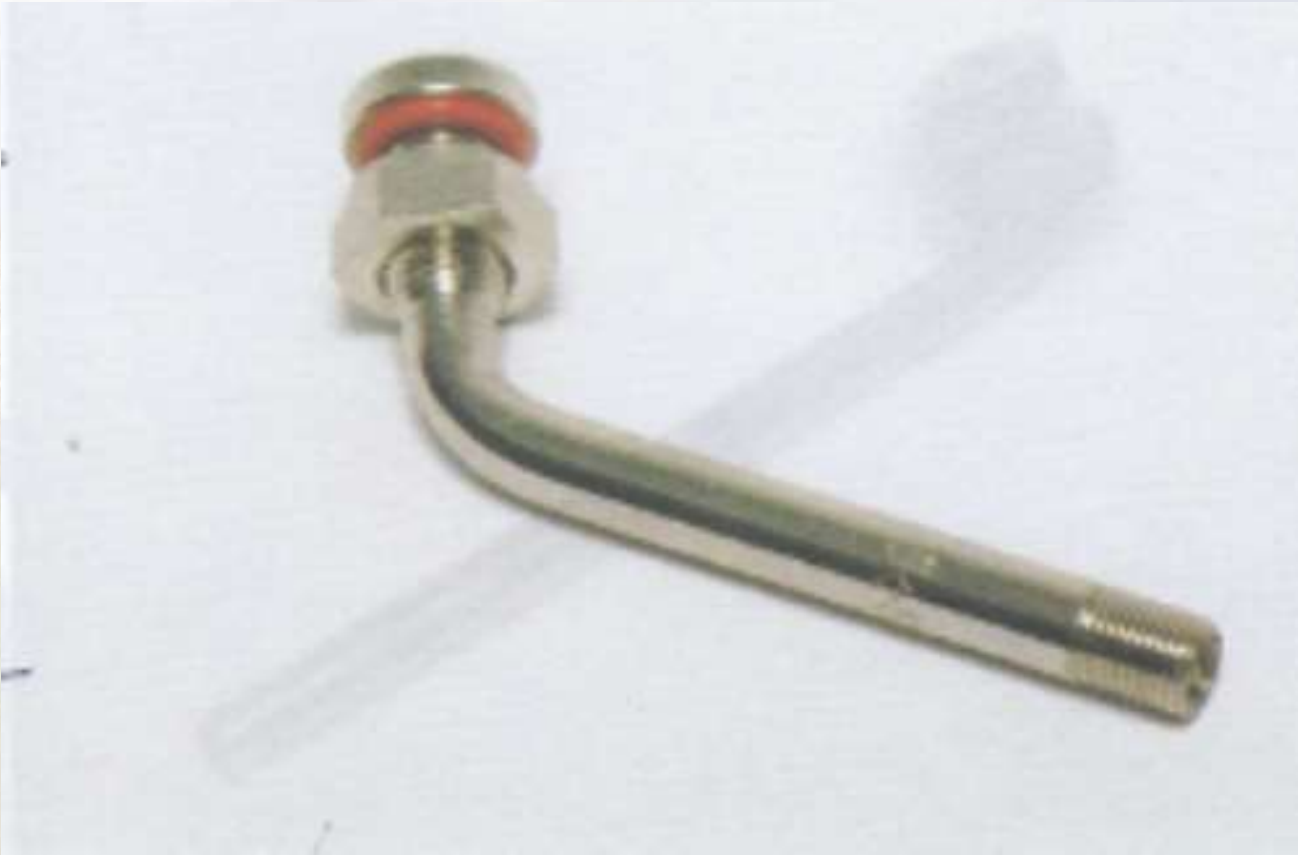
TR500 Torque 35-55 inch pounds

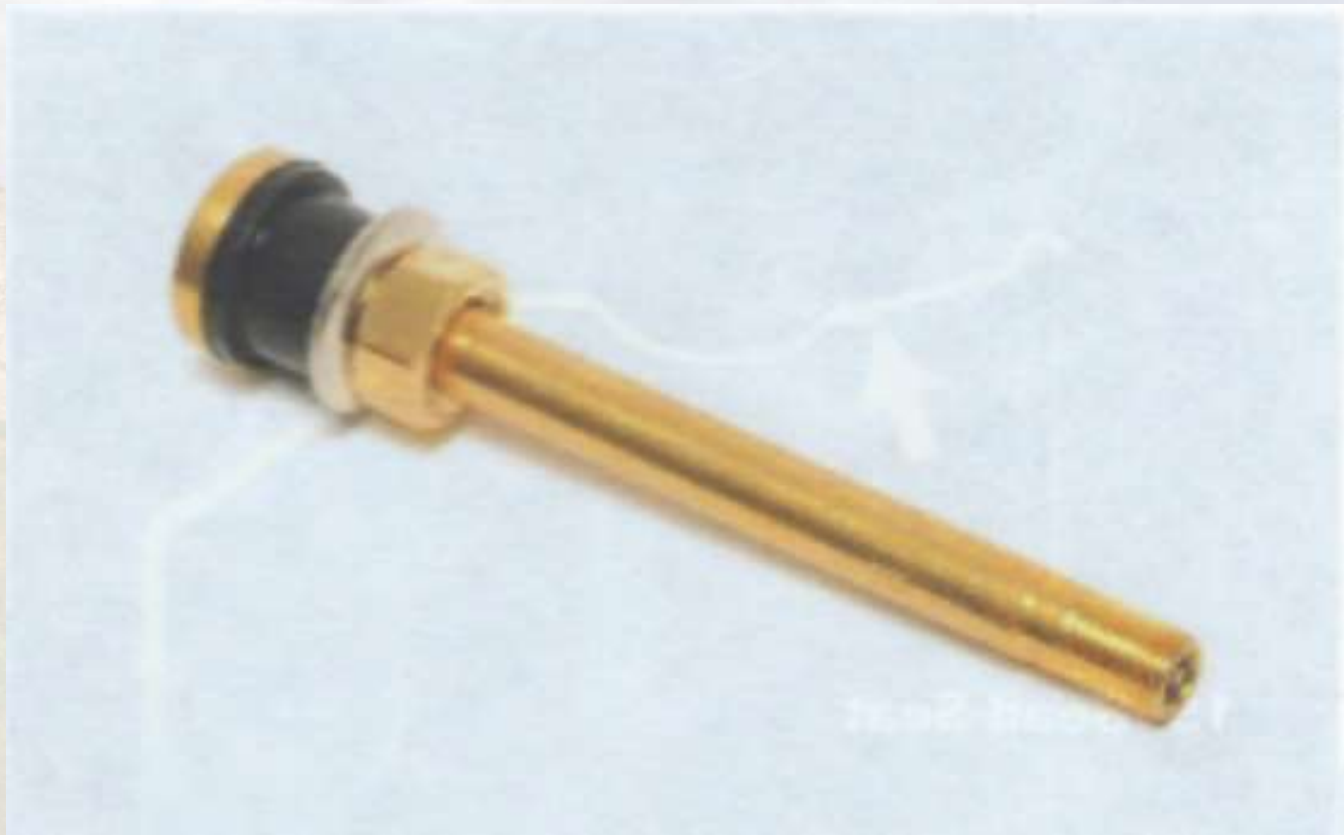
TR509, TR510, TR511 Torque 100-125 inch pounds

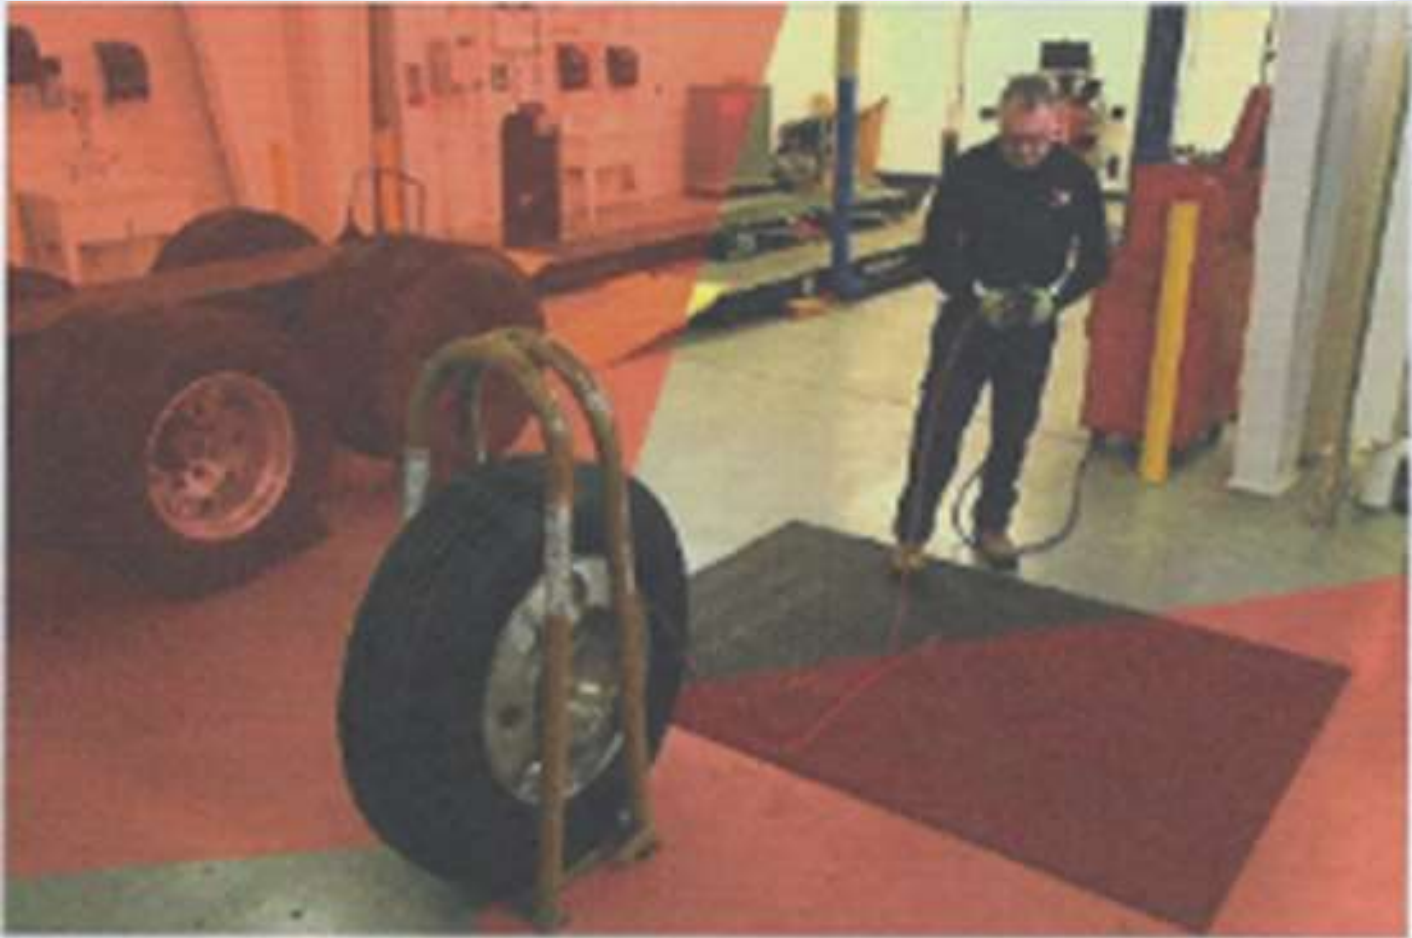
During the inflation process, technicians should always listen for any popping sound that may indicate broken cords.

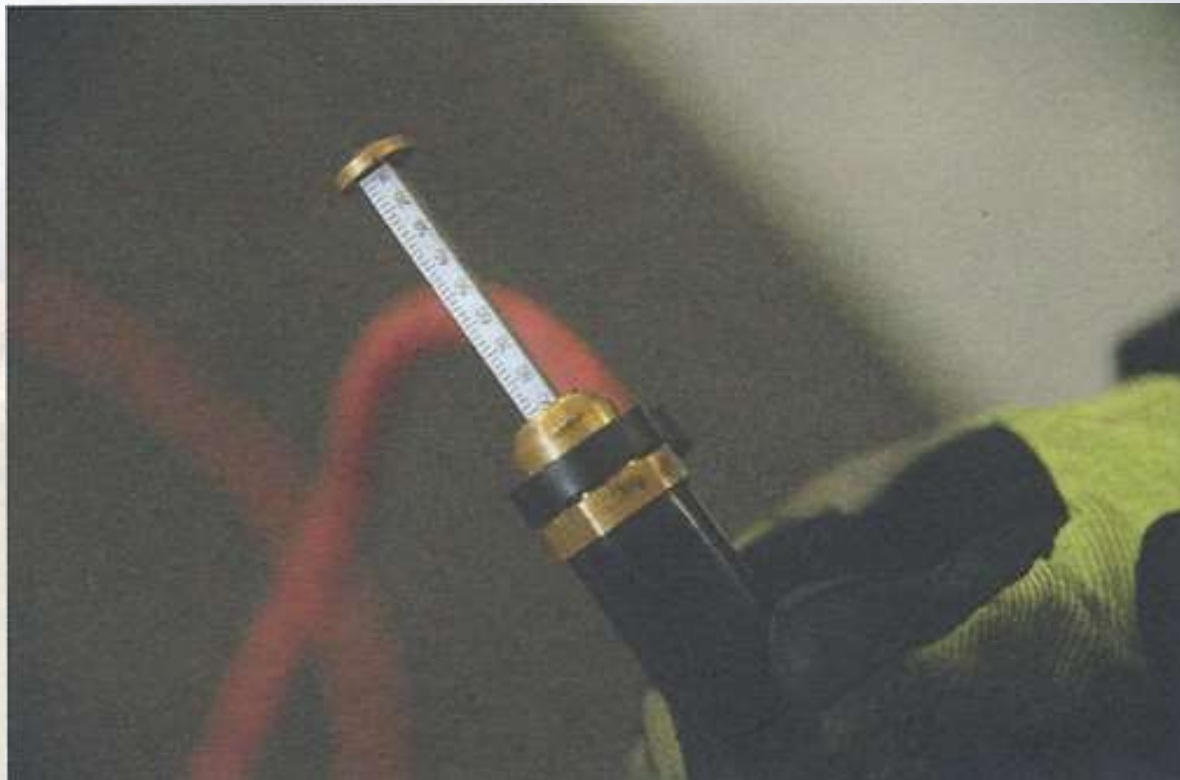
After the tire is inflated to 20 PSI, Inspect the beads to make sure they are seated

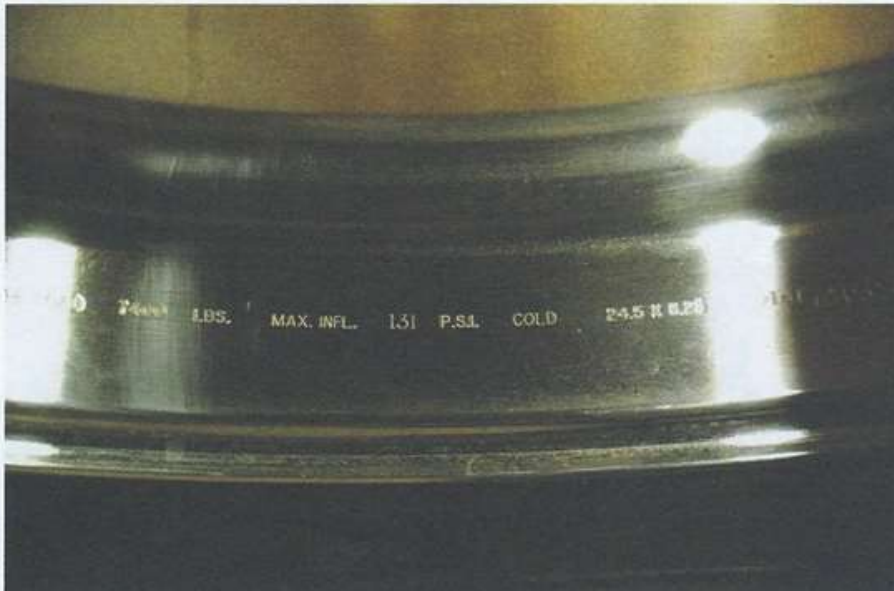
Do not exceed the maximum inflation pressure stamped on the rim.
