2022 INNOVATION CHAMPIONS CONTEST

Hydraulic Side Disc

COUNTY: Rolette County Highway Department

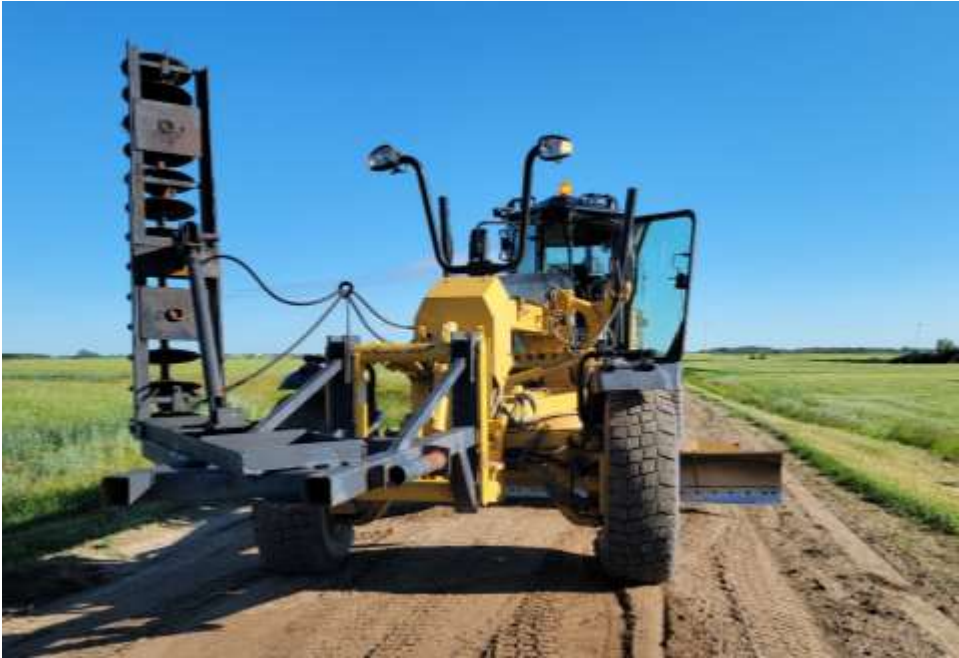
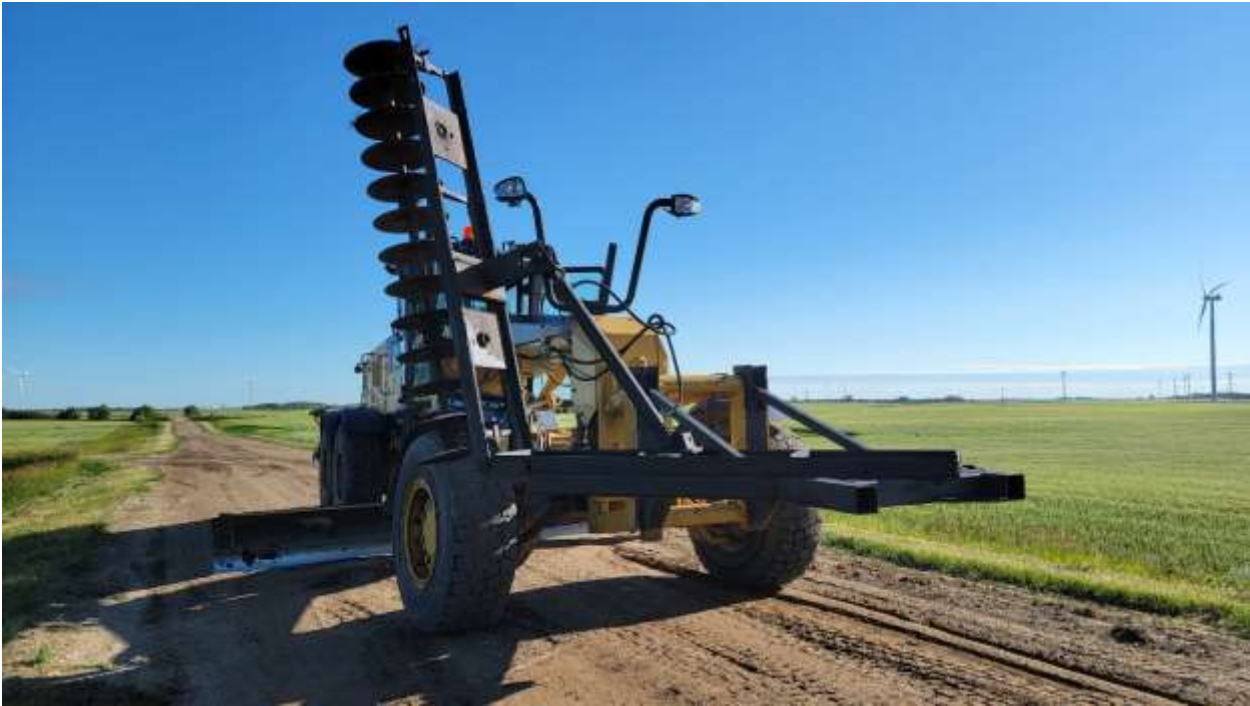
Hydraulic side disc in transport mode

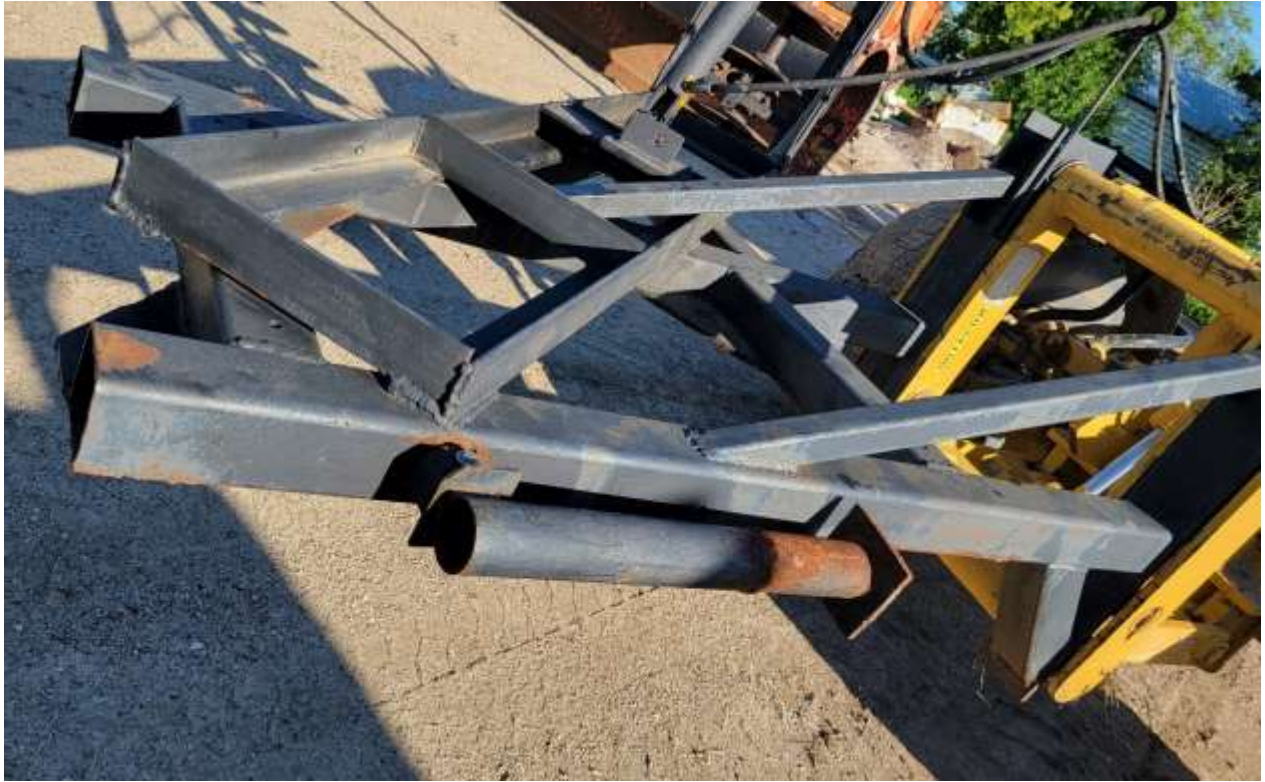
Main base frame.

The disc, on its own frame, is reinforced with angle iron and steel plates and attaches to the disc frame base with a hinge. The disc frame base is welded to the main base frame at a 45-degree angle. This was done to get the best cutting angle for the disc and to bypass the front wheel on the maintainer. The hydraulic cylinder attached to the tower on the frame adjusts the angle of the disc to the angle of the ditch. (The frame was designed and built considering the power of the maintainer and weight of the disc.) When parked the cylinder and disc are brought down to set on the ground. A safety arm and lock will be added to secure the hydraulic side disc while in transport to job location.

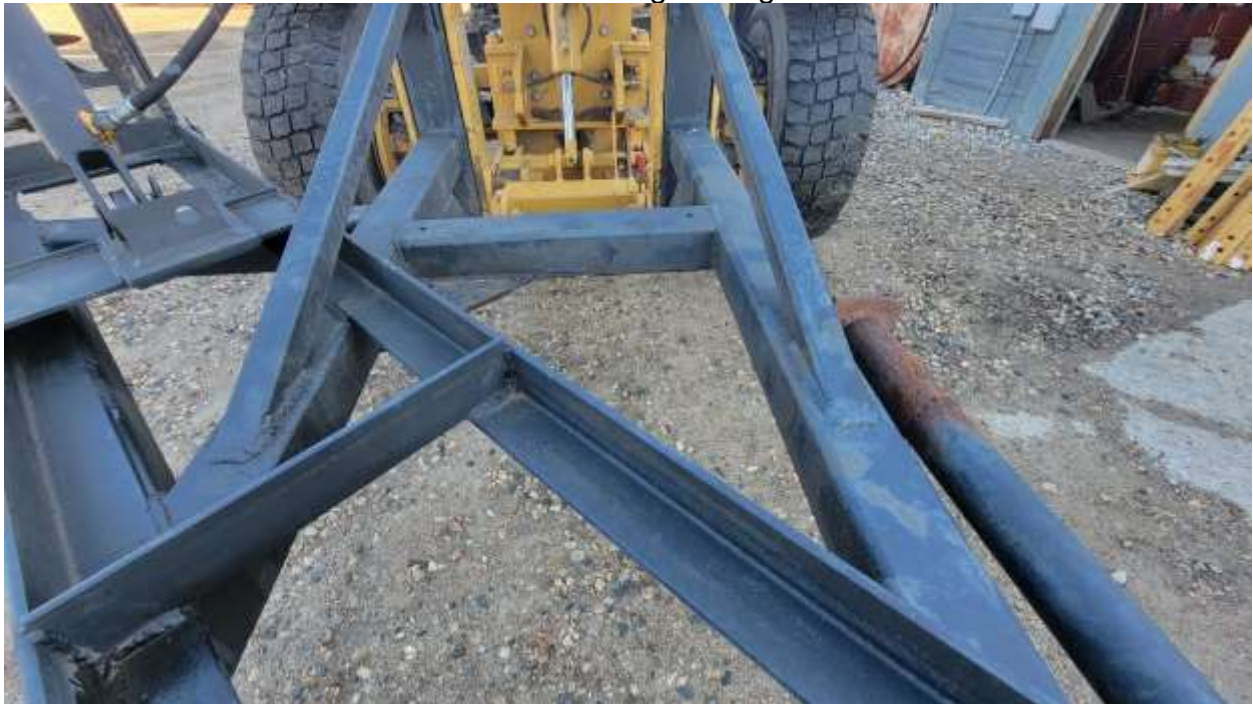
Disc base frame sets on Main frame at 45 degree angle.

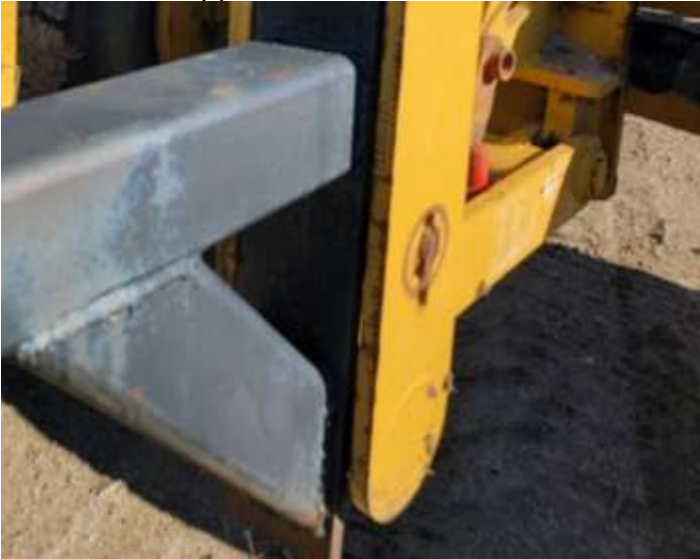
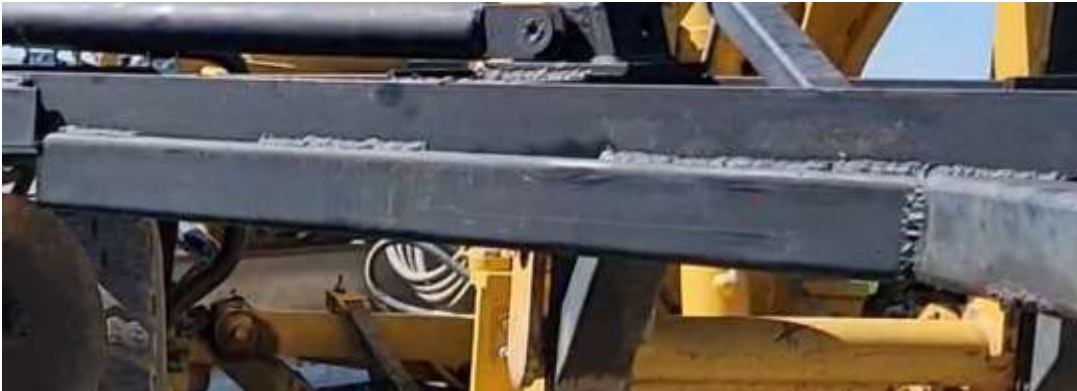
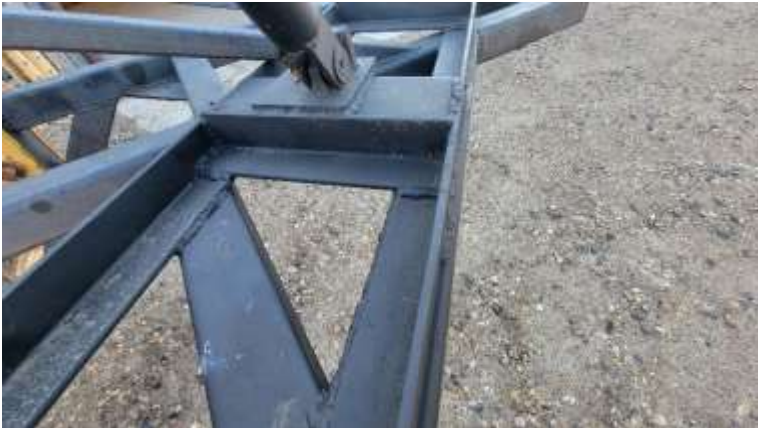
Braces and supports on main base frame

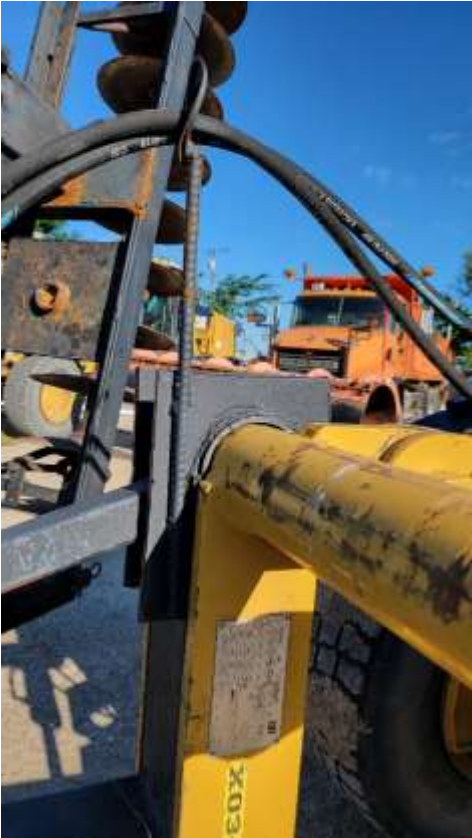
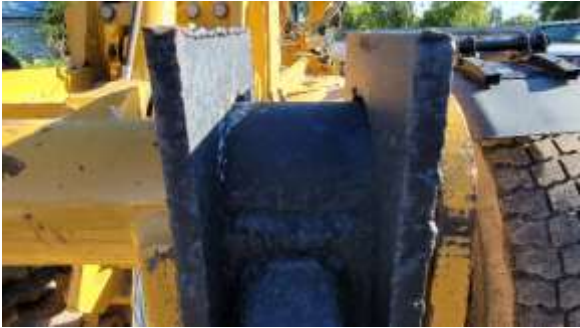
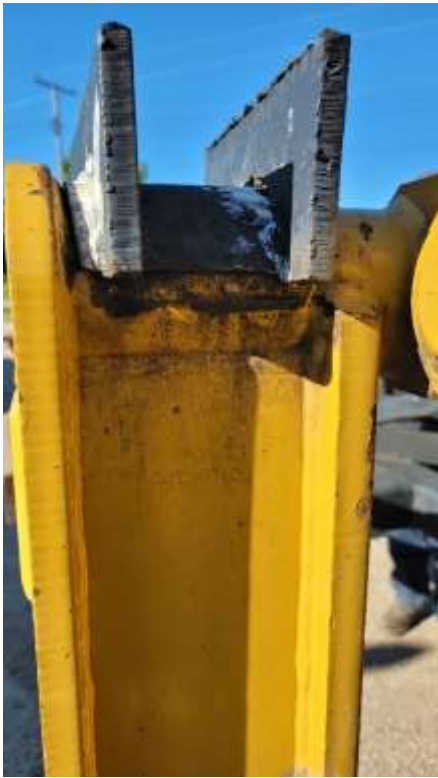
Hydraulic side disc harness attachment.

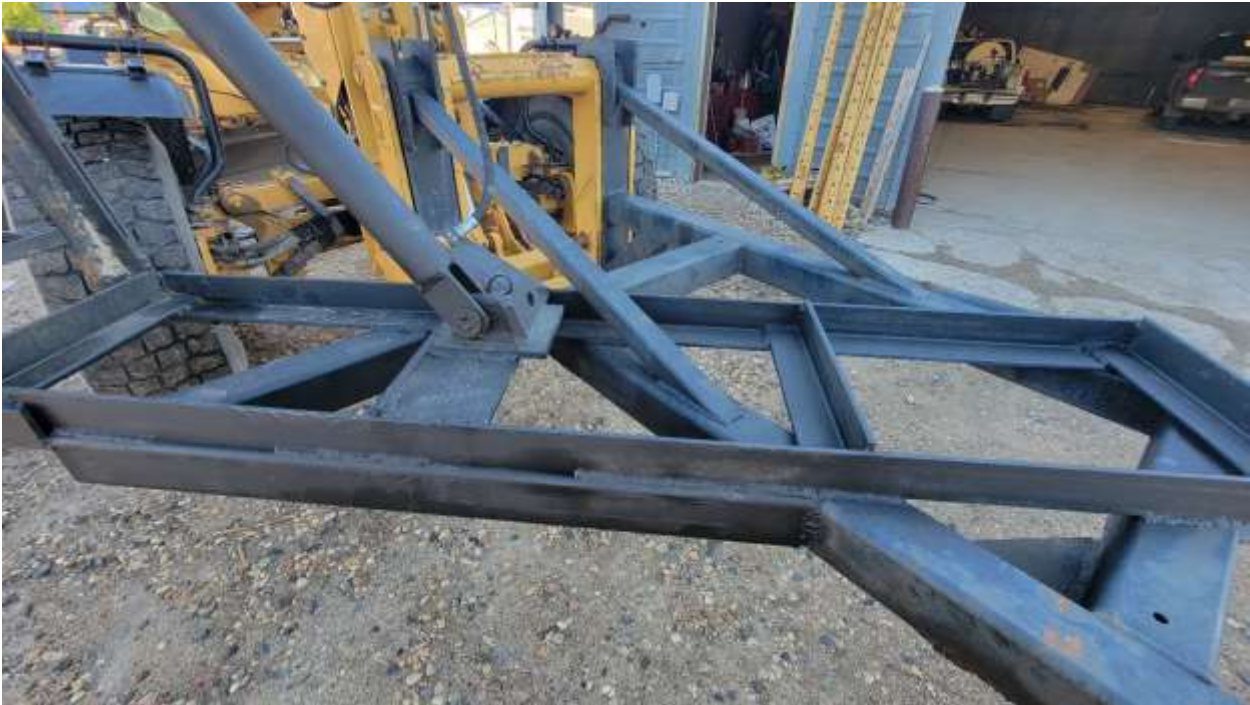
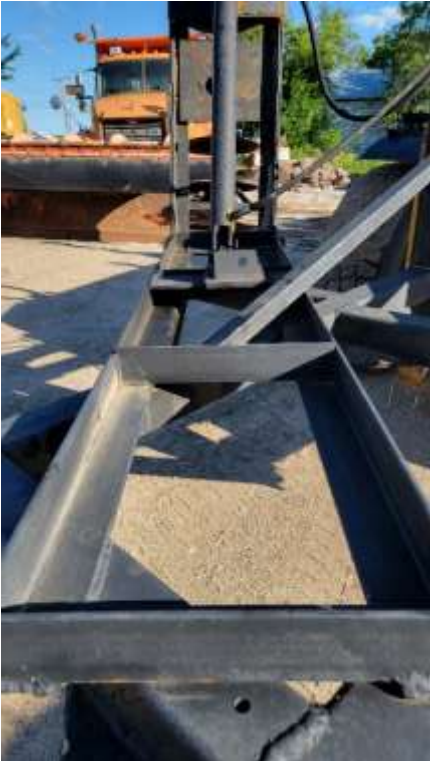
Disc base frame

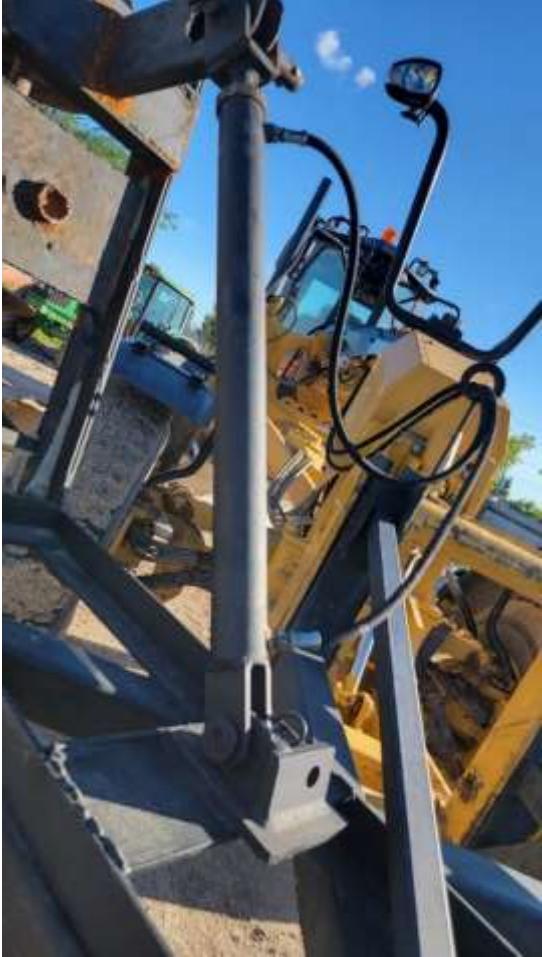
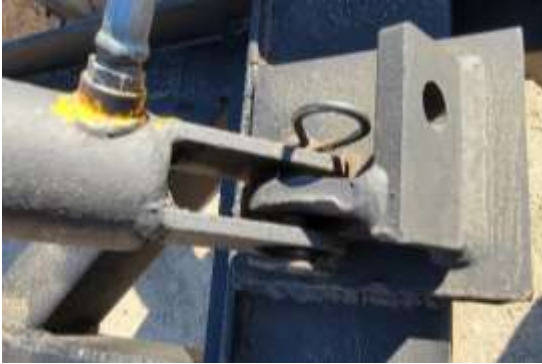
Cylinder attaches to tower and cylinder bracket on disc base frame

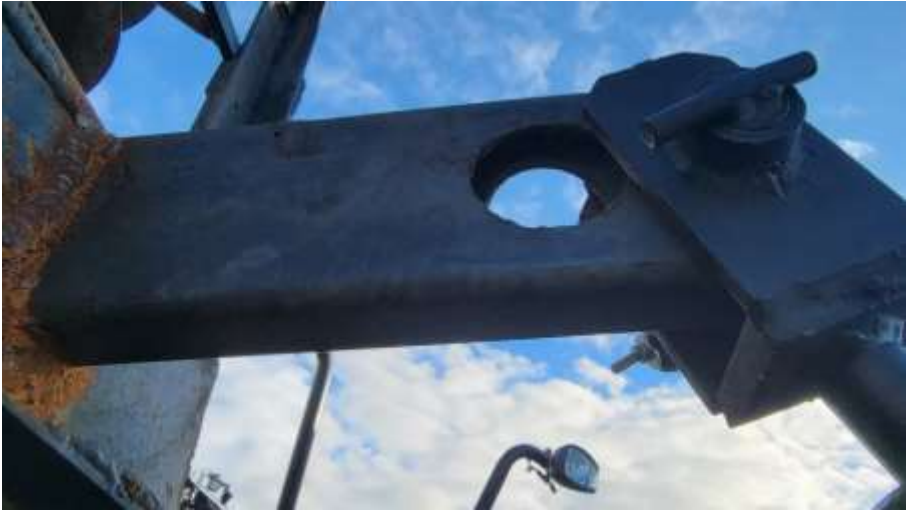
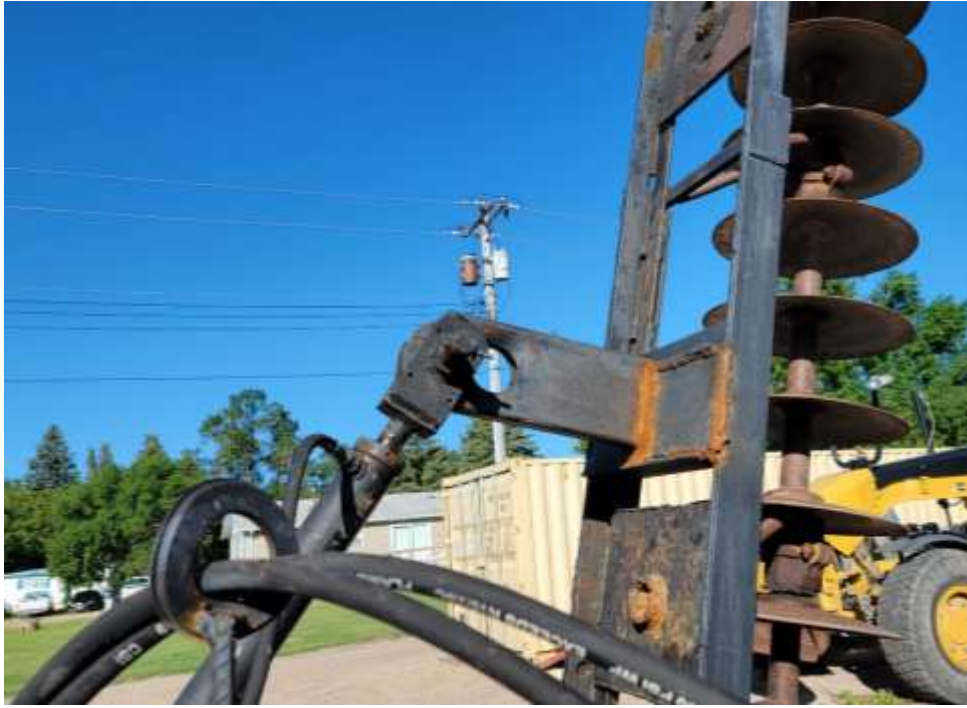
Tower for hydraulic cylinder

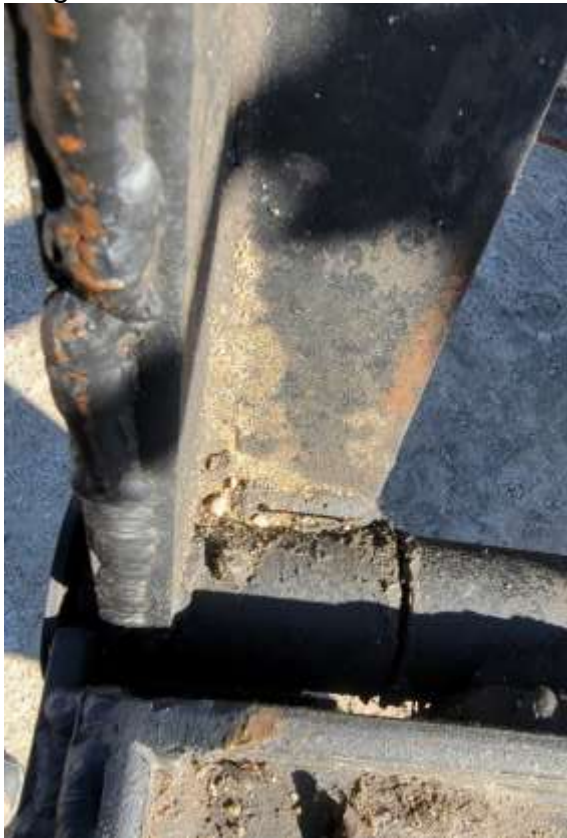
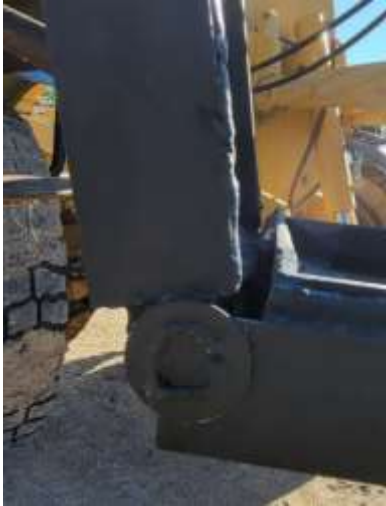
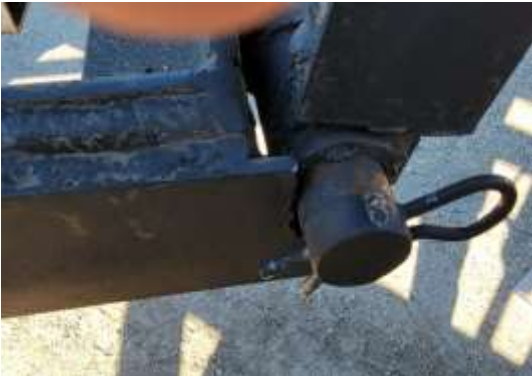
Hinge allows disc frame arm to flex

2" metal tube,
(2) 3" ends (welded to rebar, to allow for pivoting)
(1) 11 1/2" (stationary)
1 – 1 1/2" pin, 20 1/2" L and 1 1/2" steel rod inside tube

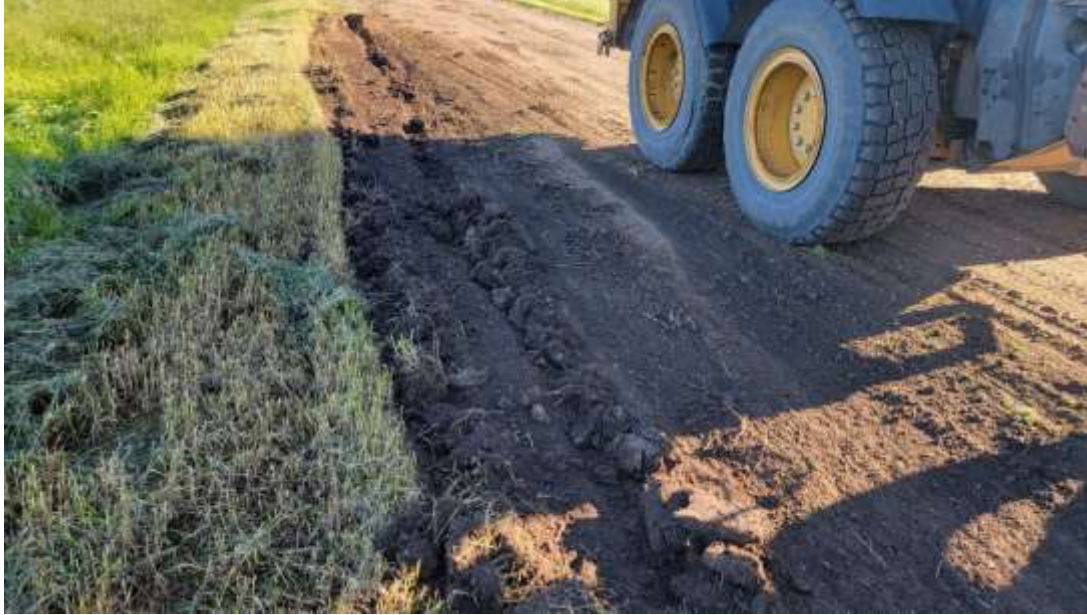
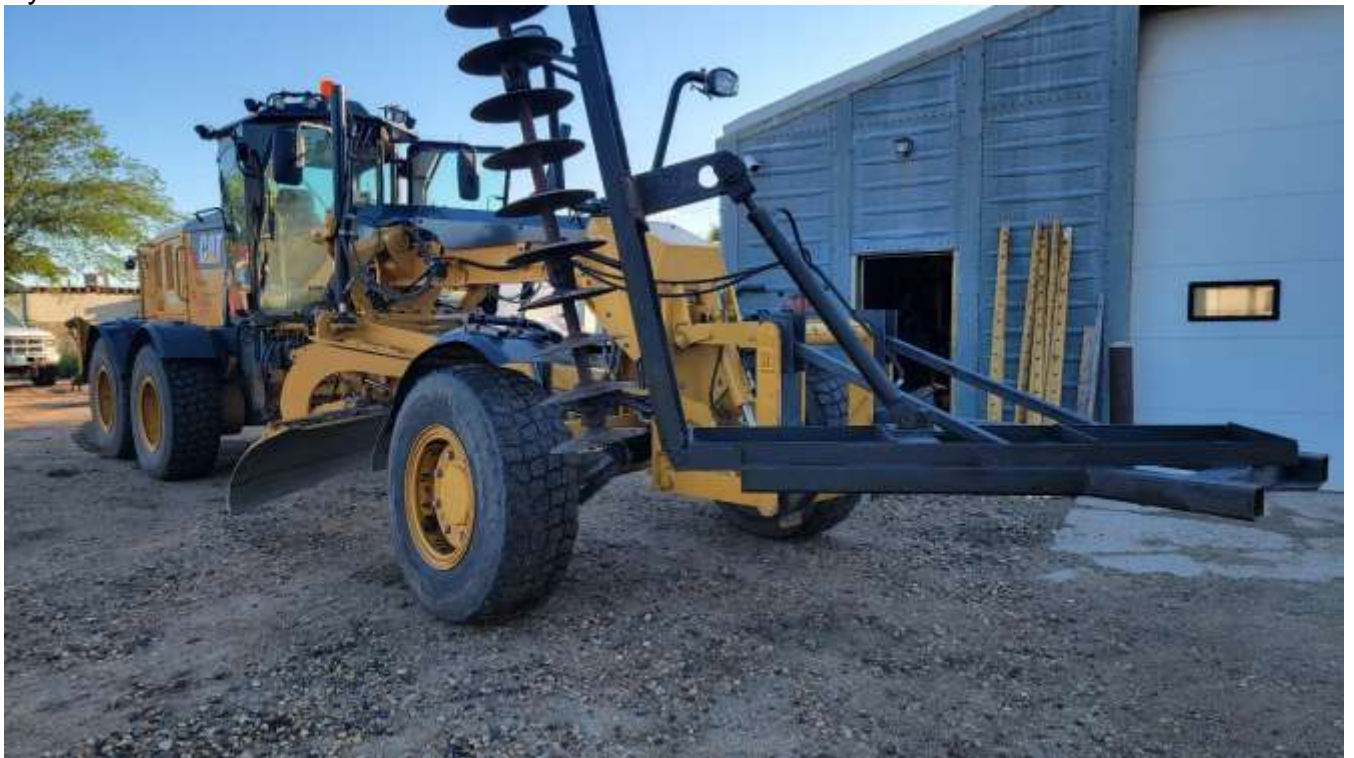
Hydraulic side disc
